**Forensic Building Science, Inc.**

# Fire Damage Report

**The Metropolitan**

2700 7th Avenue South, Birmingham, AL 35233

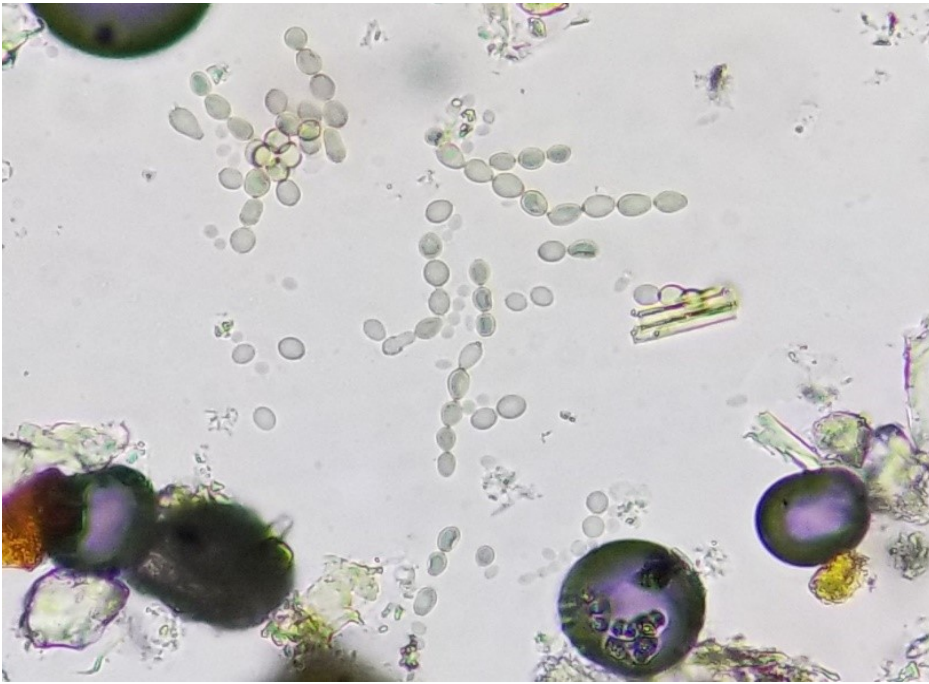
# 55 Asp/Pen like spores

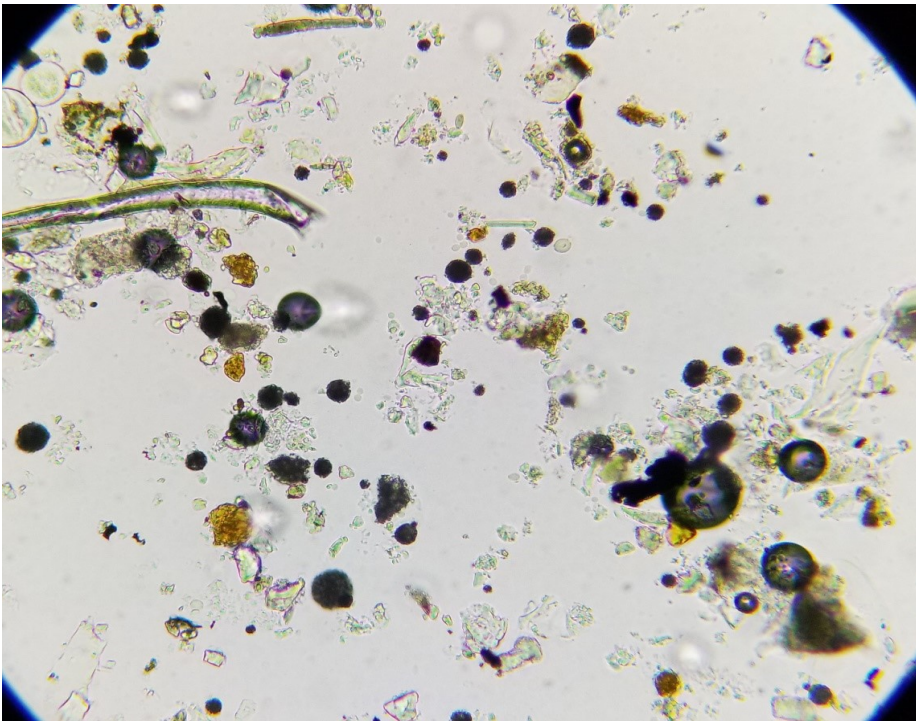
#59 Carbon black-like and char-like particles

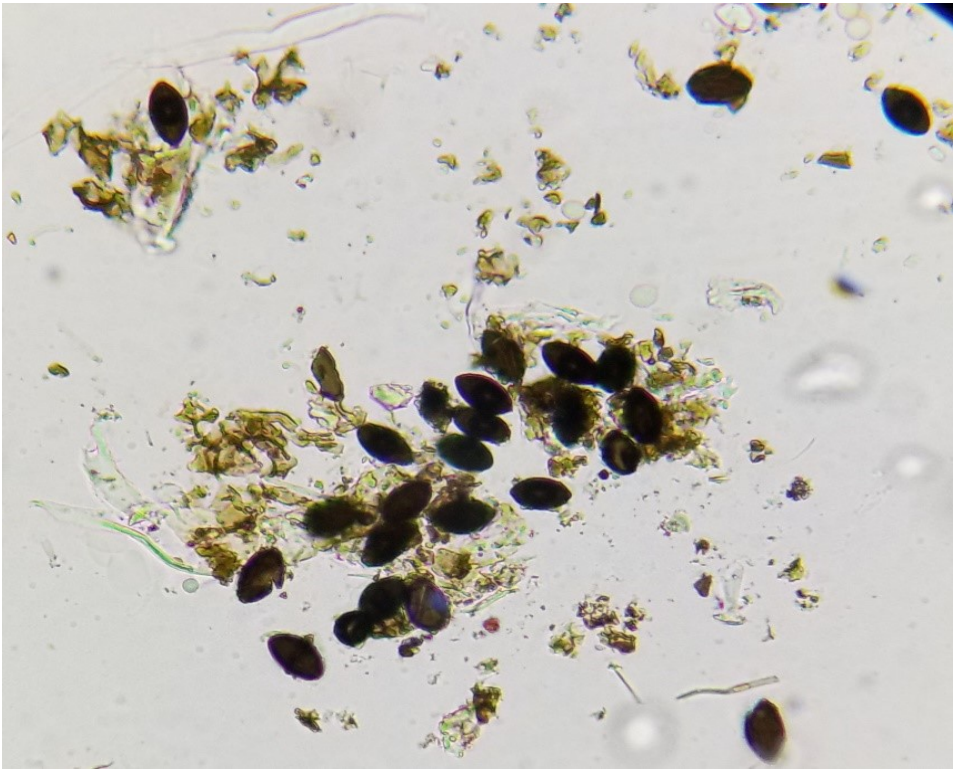
#62 other fungal growth

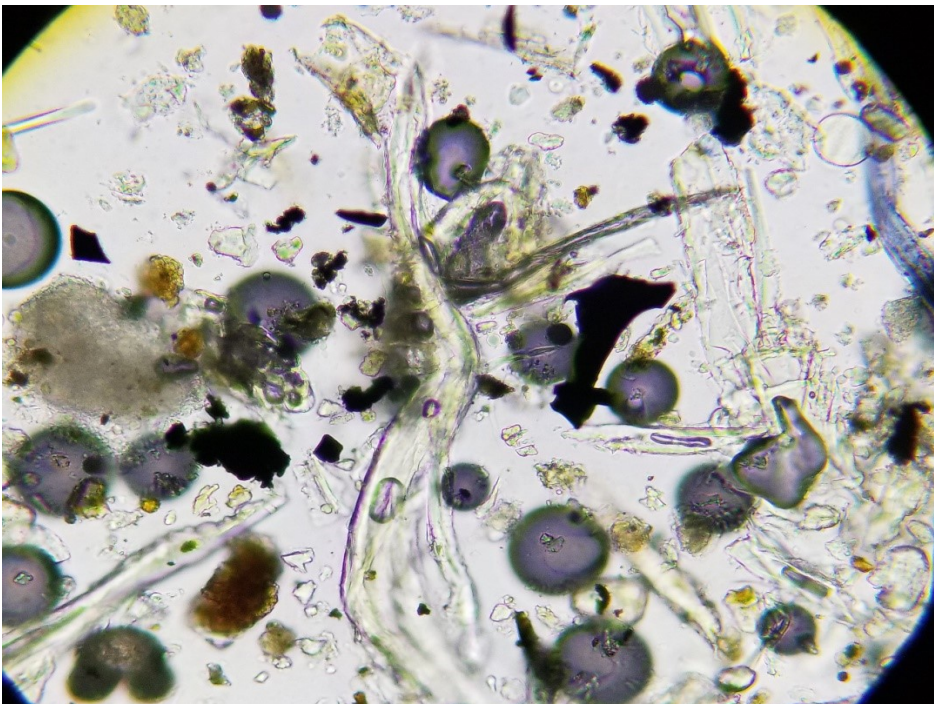
#63 Char-like particles

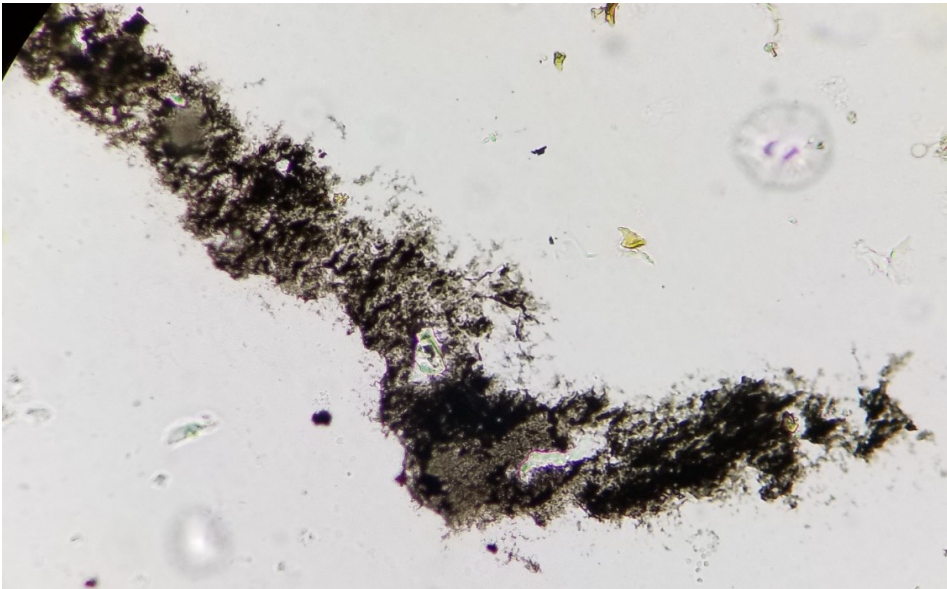
#65 Soot-like particles – Very spotty on this sample

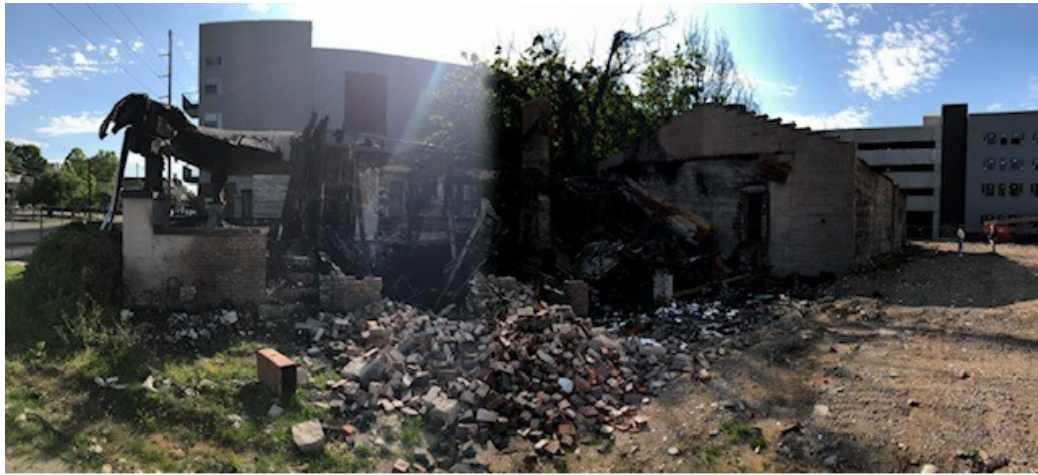
This is a panoramic picture of the remaining fire-damaged site. It consists of two buildings side-by-side that are in various states of damage.

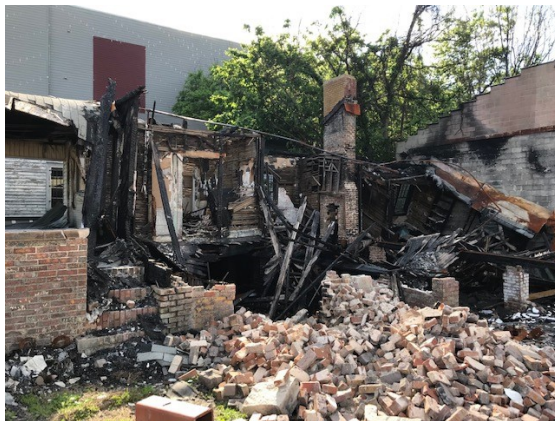
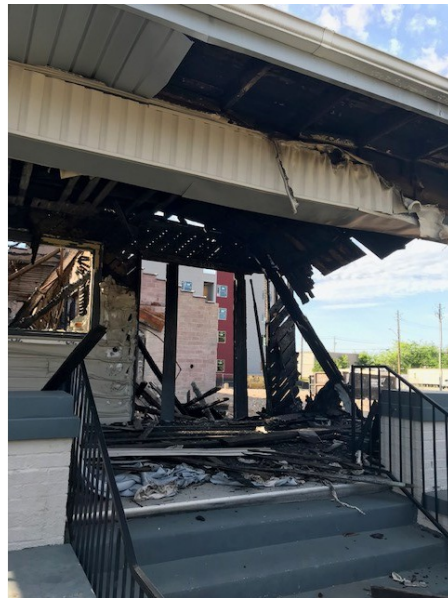
The two remaining structures that remain will continue to contaminate the Metropolitan as the char, soot, and mold are blown off these structures and throughout the Metropolitan structures. To totally remediate the char, soot, and mold these buildings must be demolished and the remaining site graded to prevent ponding.
